The Journal of RCI

CLADDING FAILURES AND DETERIORATION

BETTER DESIGN AND BUILDING PRACTICES FOR REDUCING WATER AND MOISTURE PROBLEMS IN WOOD-FRAMED COMMERCIAL AND MULTIFAMILY BUILDINGS

BY STEVE EASLEY

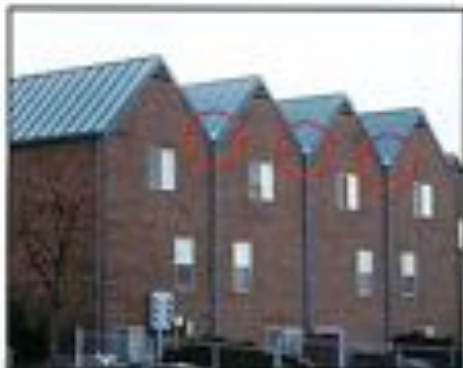
Photo 1 - Condo units.

down that valley can become trapped. If there's enough water runoff at one time, it's likely to back up under the shingles and flashing. This can turn to ice in colder climates. Photo 1 shows that a whole series of horizontal valleys has been created between these condo units. These poor-draining roofs, combined, are more likely to lead to water leaks over the life of the building. Another common mistake, shown in Photo 2, is a sloping roof into a wall that creates a horizontal valley condition, trapping water and leading to leaks.

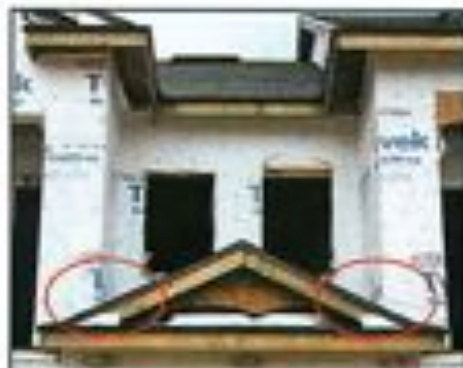
Photos 2 - Roof sloping into walls.

Any time a sloping roof or valley runs into a horizontal plane, the water flowing

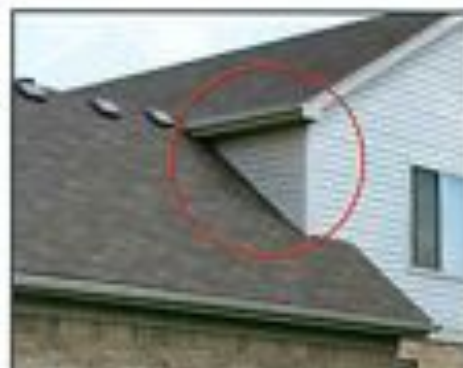
Photo 3 - Ridge intersecting eaves.

The problem with the design in Photo 3 is that all the water that runs off the higher roof is collected in the gutter. Note that there is no downspout, so all the water that runs off the roof runs toward the poorly flashed ridge cap of the intersecting roof. The solution during the original design: drop the ridge so the eaves and the gutter can run above the ridge uninterrupted. The solution now is to pitch the gutter to a downspout at the exterior corner.

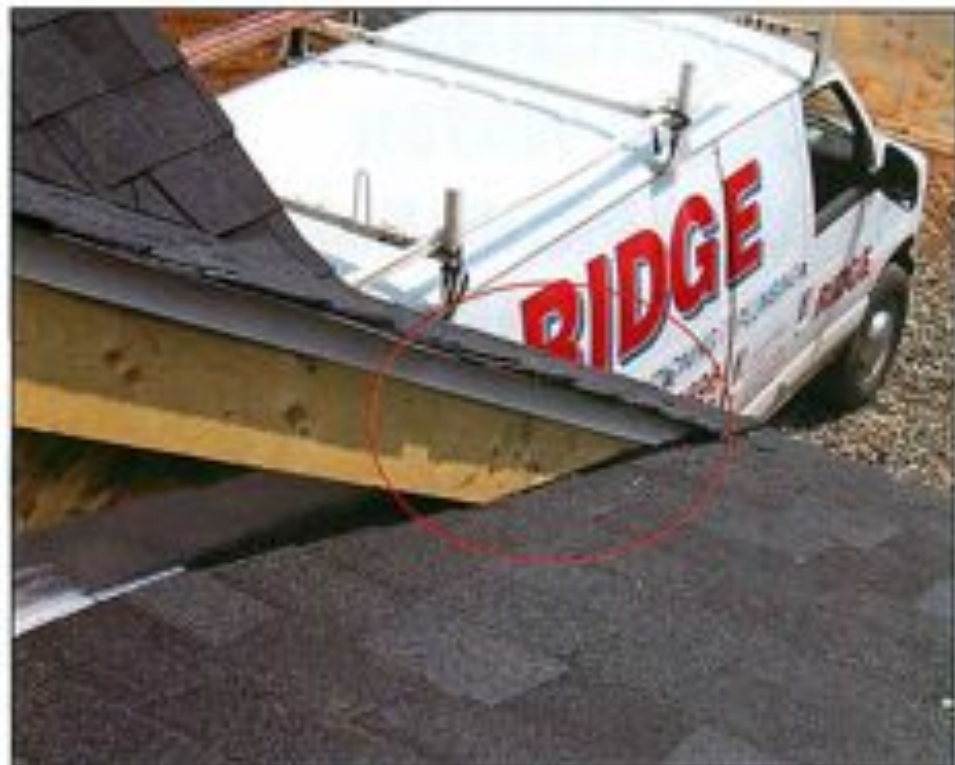
Photo 4 - Intersecting roof plane.

Whenever two roofs of different pitches intersect, it's important to detail the intersection to ensure the water's ability to shed away from the structure. In Photo 4, there's no way water draining off the roof in the foreground can drain away without getting funneled into the roof/wall intersection where the rake of the second roof blocks its path.

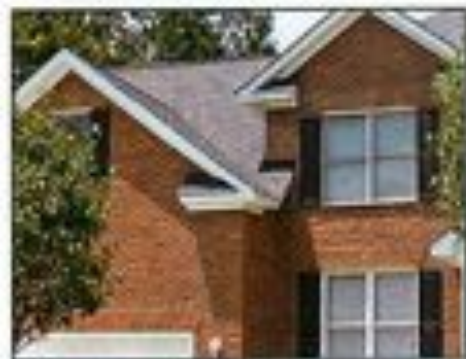
Photo 5 - Avoiding horizontal valleys.

Photo 5 shows how to detail the intersection to avoid a horizontal valley. By keeping the gable ends on different planes, the valley is allowed to run unbroken and water can drain freely.

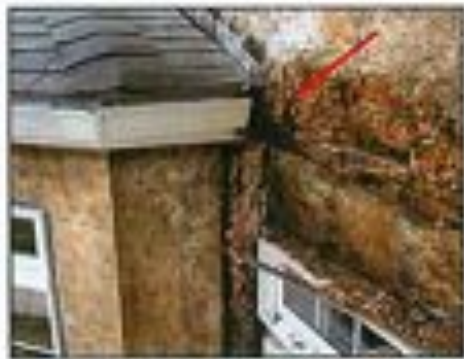
Photo 6 - Damage at roof/wall intersection.

kickout flashings (sometimes called diverters) are missing or poorly field-fabricated. Photo 6 shows damage due to lack of kickout flashing at roof/wall intersections. Kickout flashings divert water away from these troublesome details. Next to window flashing mistakes, roof/wall intersections are the most problem-prone areas.

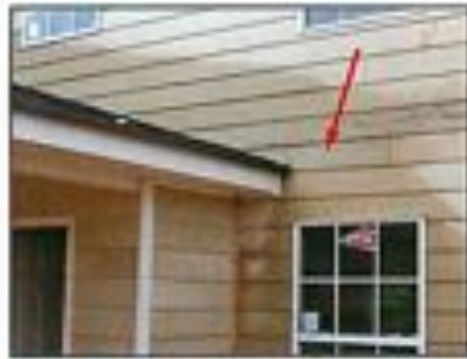
Photo 7 - Moisture at roof/wall intersection.

Notice the moisture concentration at the roof/wall intersection of Photo 7, which demonstrates the tremendous need for kickout flashing diverters.

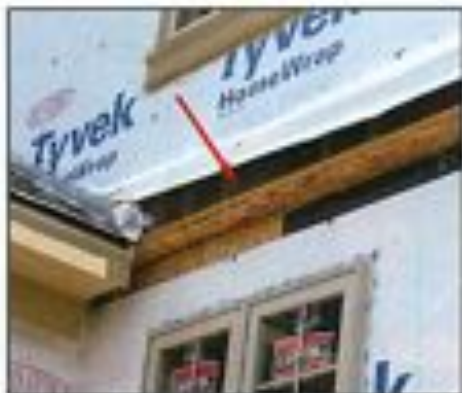
Photo 8 - Hole in water-resistive barrier (WRB).

Note the large gaps in the water-resistive barrier (WRB) at the roof/wall intersection in Photo 8. This will certainly lead to a failure. WRBs are often poorly installed at these areas. Sometimes, this leads to sloppy patchwork. Workers need to inspect and correct all unsealed penetrations.

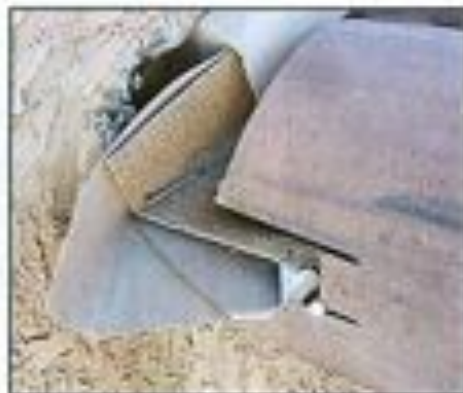
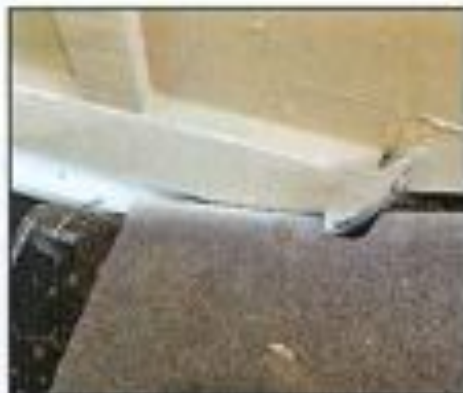
Photos 9 and 10 - Poorly fabricated kickout flashings will lead to water damage.

Field-fabricated kickout diverters, such as those shown in Photos 9 and 10, illustrate the lack of knowledge on how to properly field-fabricate a kickout diverter. Field-made diverters are often poorly made and do not work well. There is also tremendous inconsistency from one tradesperson to the

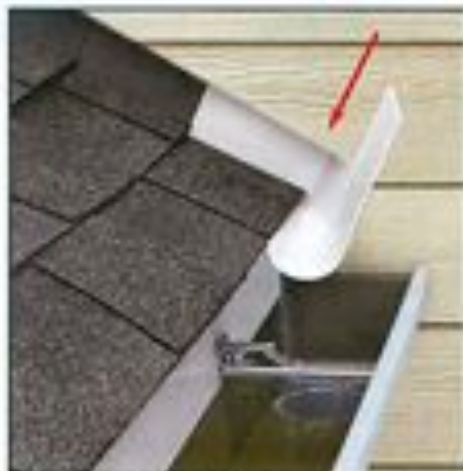
Photo 11 - Premolded kickout flashing (courtesy DryFlikt.com).

Premolded, seamless kickout flashings (Photo 11) are an excellent solution. They perform better than field-fabricated metal and cost only \$10 or so. This product can work with almost any roof pitch. It is made of polypropylene, so it works well in both cold and hot weather.

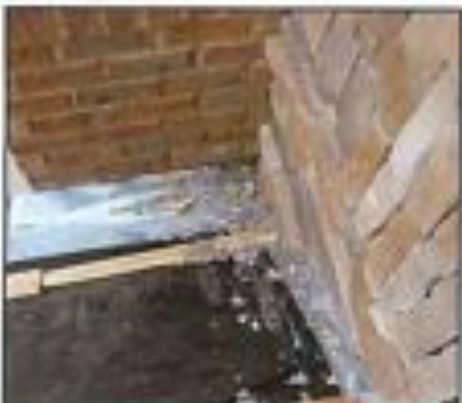
Photo 12 - Metal flashing reverse shingled over brick.

Properly installed flashing is the last defense against leaks. In Photo 12, the metal flashing is reverse shingled over the brick. The design is poor because it creates a horizontal valley. Proper inspection is required to avoid flashing-related leaks.

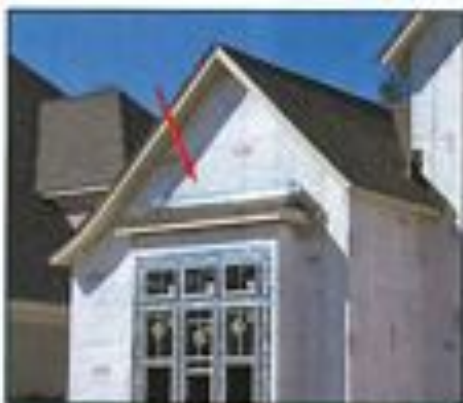
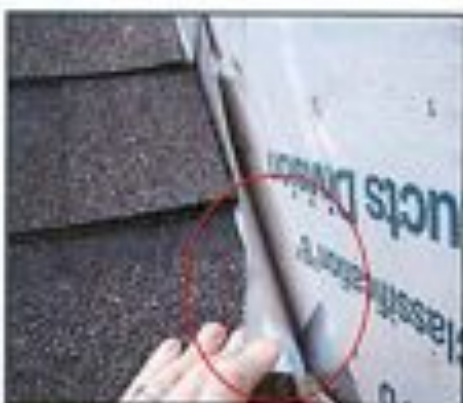
Photos 13 and 14 - Reverse-shingled weather barriers.

Look carefully at Photos 13 and 14, and it is apparent that the house wrap is reverse shingled. The house wrap is behind the step flashing, which means that any water that gets in behind the cladding can easily be funneled into the wall, rather than draining away from the wall. The wrap should go

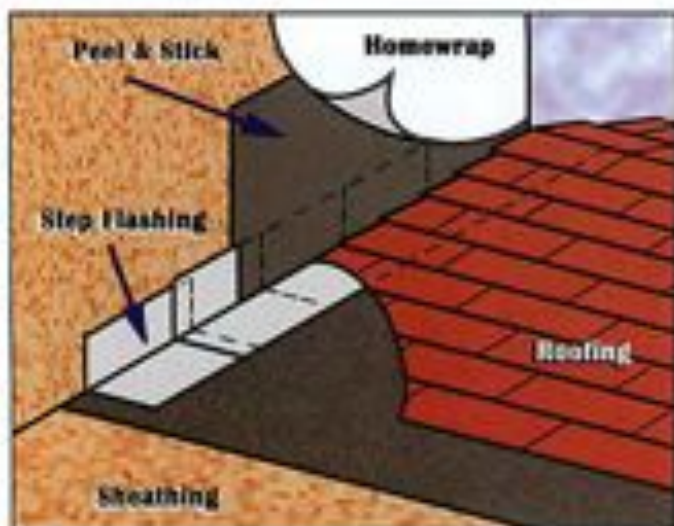
Photo 15 - Peel-and-stick flashing from sheathing onto metal flashing.

Use peel-and-stick flashing at step flashing wall intersections. This provides a tertiary drainage path for water that gets behind the wrap. Water that gets behind the house wrap now runs down the wall and is diverted over the peel-and-stick onto the step flashing.

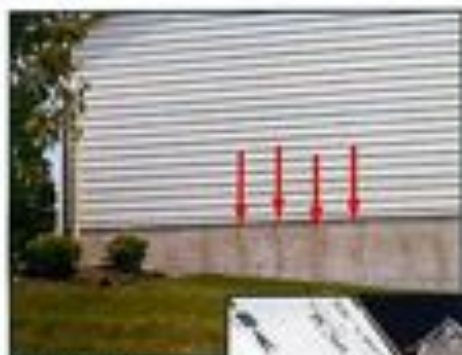
Photo 18 - Vinyl Siding Drainage

All cladding leaks, and vinyl siding is designed with weep holes to allow for drainage. In Photo 18, the secondary moisture barrier is doing its job, shedding enough water that wet spots are clearly visible underneath the vinyl siding.

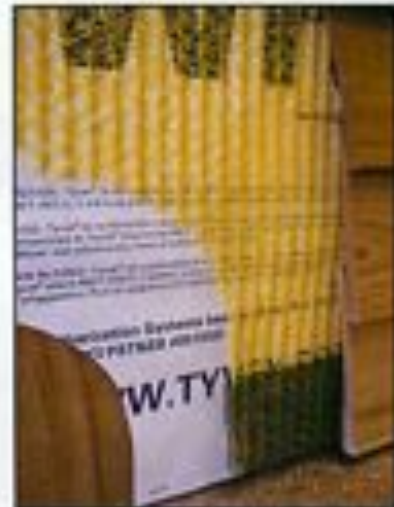
Photo 20A - Rainscreen product (Home Slicker cross section).

Rain screens, a space between WRB and siding, provide better drainage and drying behind claddings. The product in Photos 20A and 20B are manufactured by Benjamin Obdyke and are part of the Hoesl Slicker line. Products like these reduce the potential for water intrusion in two ways:

1. They create a drainage space for water to drain, and
2. They create a capillary break to prevent water flow by capillary action.

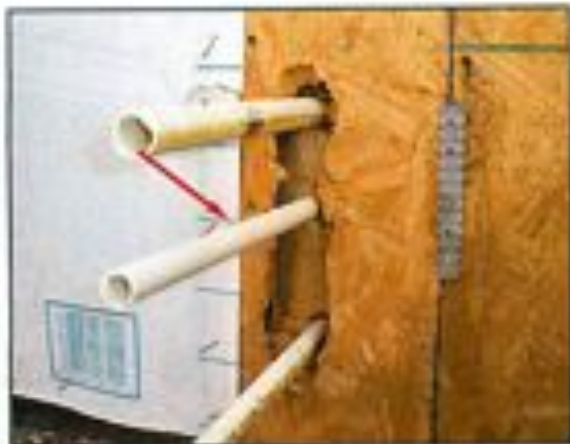
Photo 21 - No flashing around pipes.

It takes only minutes for wall components to get wet, but it takes days, weeks, or months for them to dry out. If the wetting rate exceeds the drying rate of building materials, mold and decay can occur. Notice there is no flashing around the pipes coring through the wall pictured in Photo 21. It would be very easy for water to run down the pipes and flow directly into the wall.

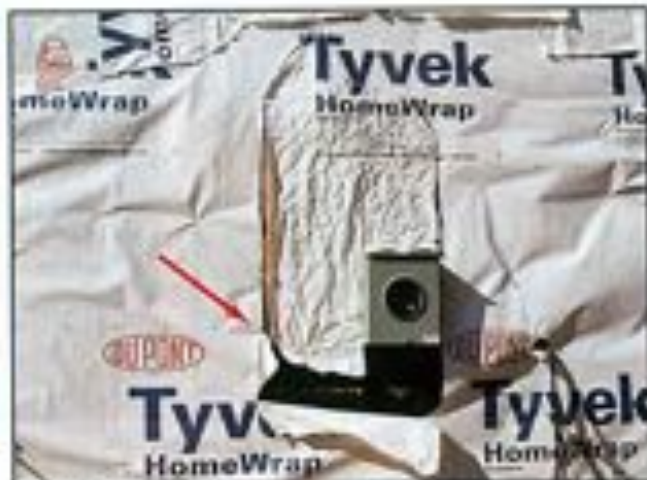
Photo 22 - Poor detailing at electrical meter.

Photo 22 shows poor detailing at the electrical meter base and will surely lead to problems.

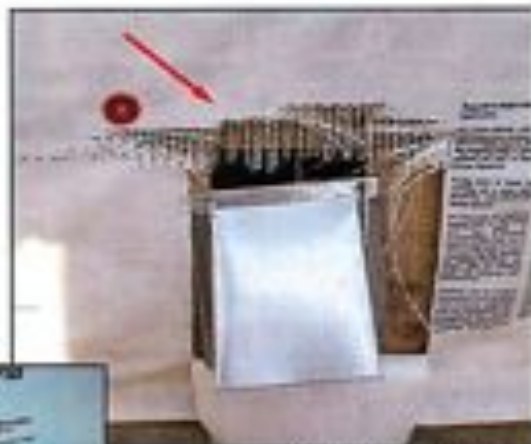
Photo 23 - WRB at vent should be flashed.

Cutting large holes in the house wrap, as shown in Photo 23, defeats its purpose. The proper cutting technique is to X-cut the house wrap, slide the vent through the X-cut, and seal around the penetration with an acrylic tape (or a peel-and-stick flashing) before securing the faceplate. Photo 24 shows a prefabricated flashing device made by QuickFlash that stretches around the pipe and seals it.

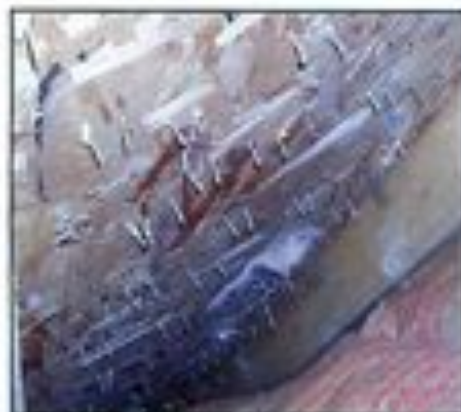
Photo 25 - Overstapling WRB.

Every staple through the water-resistant barrier is a potential water leak. Crews should be instructed to install the WRB according to manufacturers' instructions. Photo 25 illustrates over-fastening with staples.

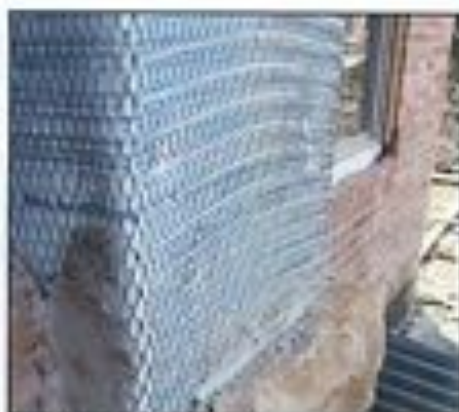
Photo 26 - Synthetic stone.

Synthetic stone (Photo 26) creates a unique challenge. Synthetic stone systems leave no air space to promote drainage like brick veneer. A solution is to apply two layers of water-resistant barrier material before installing the lath.

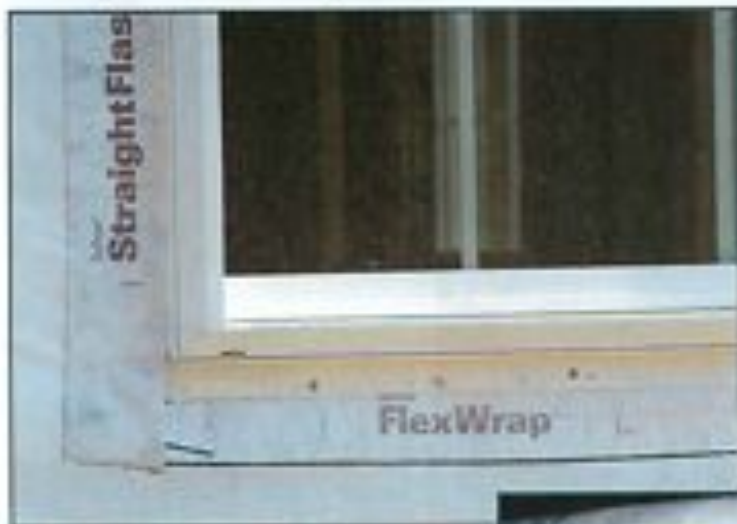
Photo 28 - Proper window flashing at sill. The sill flashing was installed before the window.

- **Step 1:** WRB and sill flashing are installed before the window (Photo 28). Begin with a sill flashing that covers the rough sill and has a bottom flap that laps over the top of the WRB (house wrap). This will help ensure that any water that leaks through the window drains out over the WRB.
- **Step 2:** Sealant is applied at the head and the jamb areas; then install the window. Jamb flashing can go in after the window has been installed and should lap over the window flange to prevent wind-driven water from getting past the window into the rough opening.
- **Step 3:** Install the head flashing from the nail fin at the window head onto the wall sheathing (see Photo 29). Reinstall WRB over the head flashing.

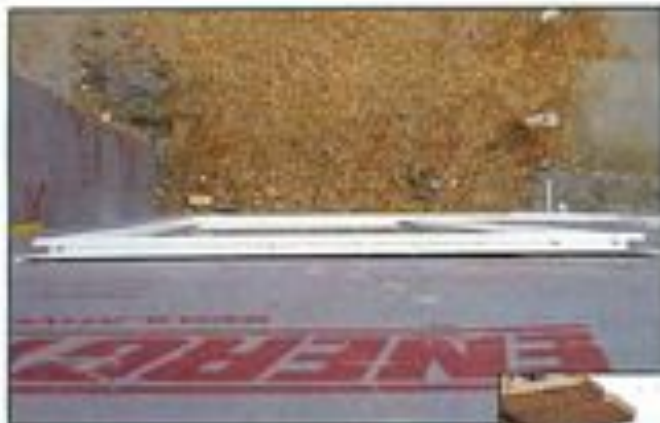
Photo 30 – Note the gap between the nail fin and the sheathing.

Photo 30 depicts what water running down a wall "sees" as it approaches the head of the window, underscoring how very important it is to properly flash at the win-

ow head. Sealant alone won't keep the water out. If the sealant ever separates and fails, there is a perfect entryway point for water into the structure. Always use compatible sealants and flashing.

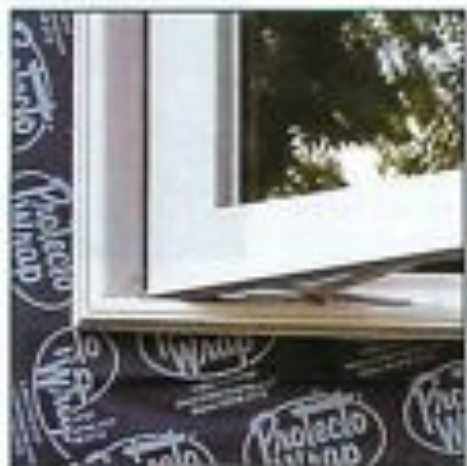
Photo 32 – Improper sill flashing.

The flashing in Photo 32 is applied over the top of the nail fin below the window. This is a mistake. The sill flashing goes on before the window is installed.

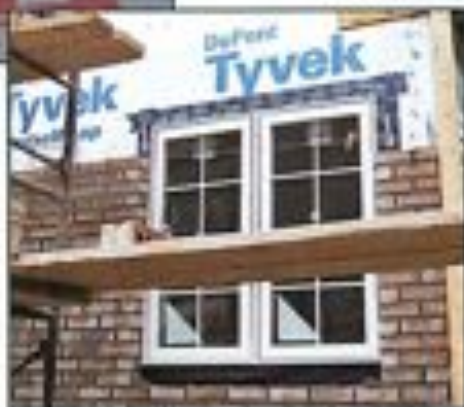
The head flashing on the window in Photo 31 is reverse-lapped over the house wrap. Before applying the head flashing, a flap needs to be cut in the house wrap so that the head flashing can adhere directly from the nail fin at the head onto the wall sheathing (see Photo 29). Once the flap is folded back down over the head flashing, water draining down the wall above the window will drain outside, not behind the head flashing.

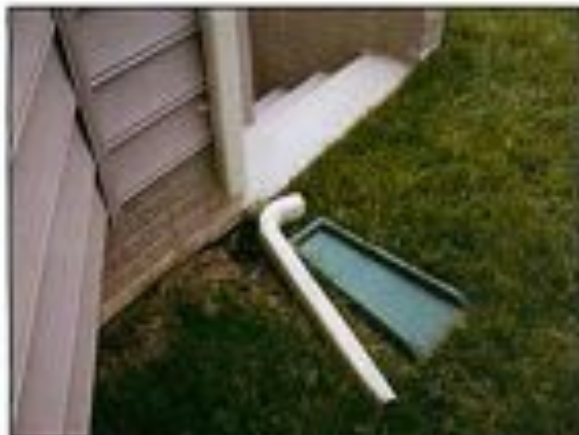
Photo 34 - Disconnected downspout.

Water problems can often be traced to poor drainage around the home. Exterior water problems can easily create interior moisture problems. Photo 34 illustrates a

disconnected downspout. Water that runs off the roof is being funneled near the foundation, which can create a tremendous moisture load at the foundation.

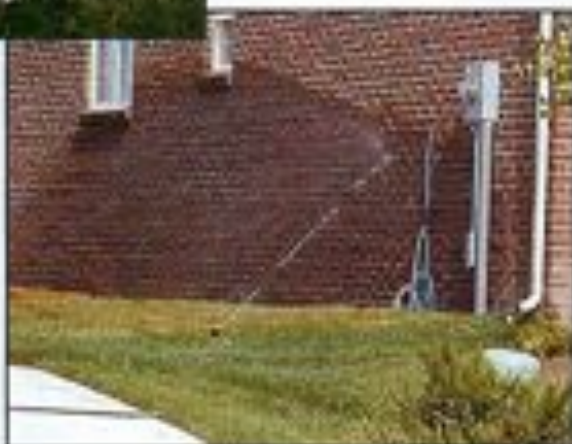
Photo 35 - The owner factor.

This sprinkler is pouring over 100 gallons per hour of water onto the wall depicted in Photo 35. This is an "unexpected design condition" and exemplifies why redundancy with flashing and WRBs is so important. The only way to avoid problems caused by the owner irrigating this wall is to make sure a WRB behind the brick is impeccably detailed, a drainage cavity and weep holes remain open, a backfill that drains well was installed, and there is good perimeter drainage.
