Coastal

Insulation That Works

With closed-cell spray foam, the benefits go way beyond R-value

by Steve Easley

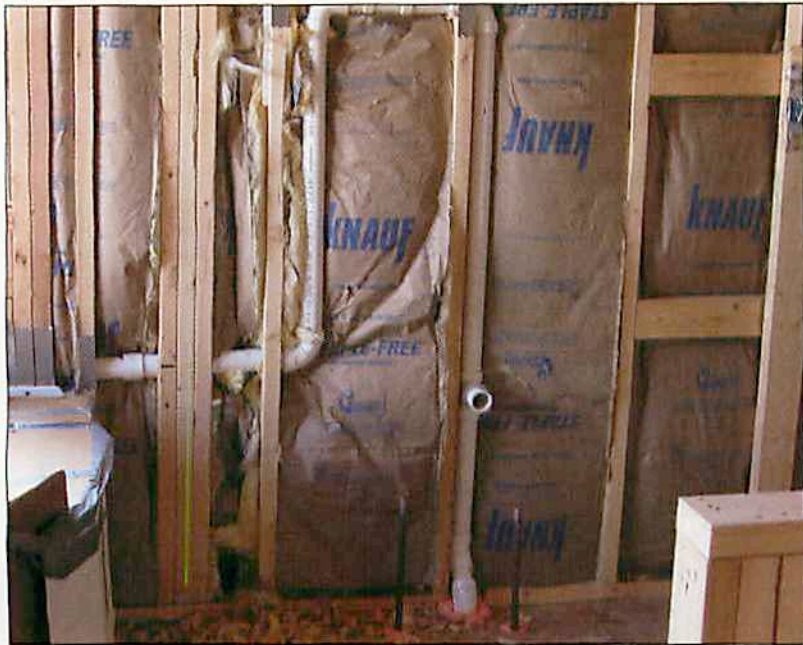
Batt insulation works best when it is fully lofted, not jammed into the tight spaces (left). Compression of the batt reduces the number of air pockets that provide the material's insulation value. It also leaves a hollow between the insulation and the dry-wall, creating areas where air can circulate. These voids can siphon off energy and may create conditions for condensation and moisture problems.

promise occupant comfort and increase the building's energy loads. A sloppy insulation job can also lead to moisture problems by creating thermal conditions in walls and ceilings that promote condensation, wetting, mold growth, and rot.

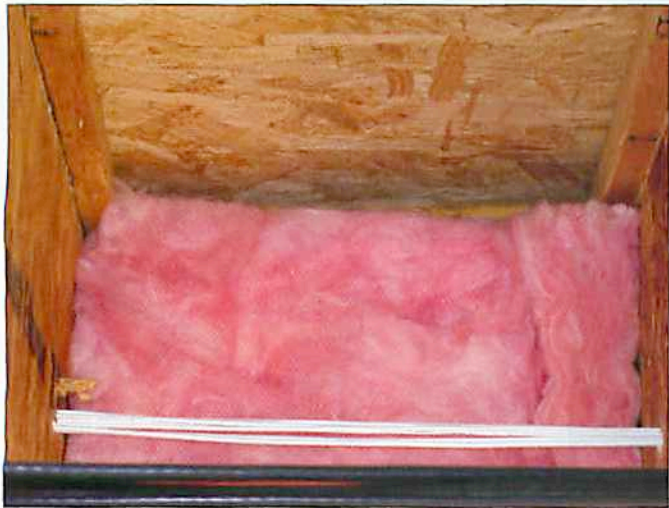
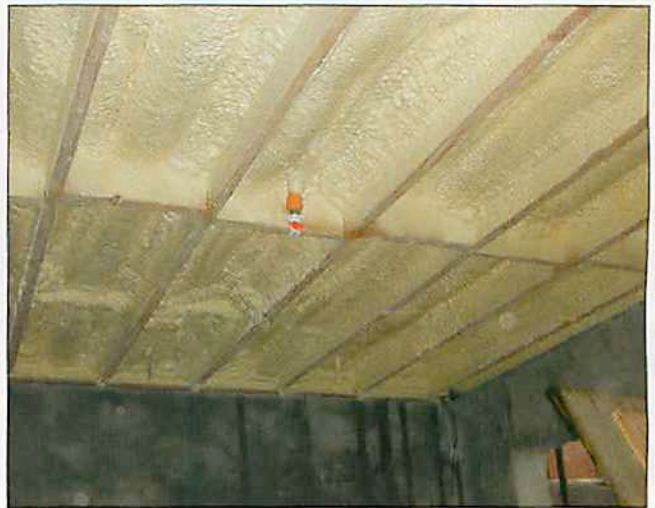
Living Spaces Over Garages

Living spaces over garages create conditions that demand careful attention to insulating the floor. Yet it is difficult to support the insulation in this cavity, and oftentimes the insulation falls onto the garage ceiling. This separation between the insulation and the living space floor creates a thermal bypass that compromises the value of the insulation. Air easily infiltrates in at the band-joint area over the top of the insulation, which scavenges away heat. This often freezes plumbing pipes, creates cold floors, and can lead to major mold and water damage. Builders often try to solve the problem by supplying forced-air heat near the plumbing, but this only succeeds in pressurizing the space with warm, humid air. As this air exfiltrates through the exterior cracks, it can condense and lead to even worse moisture and mold problems at the band-joint areas.

The issues are easily solved with ccSPF, which sticks to the bottom of the subfloor so insulation and air barrier are always in contact. The foam also stops air infiltration. It is a good idea to wrap any plumbing with a thin layer of fiberglass insulation before spraying foam over it to make servicing the plumbing easier.

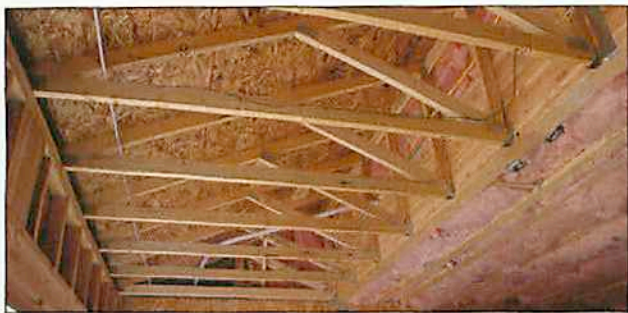
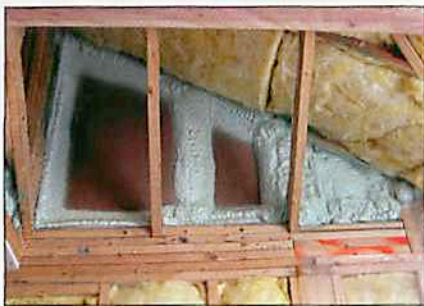
Attic Knee Walls

These are areas where the insulation on the back side of unsheathed walls is exposed to outdoor temperatures and airflow. They are often adjacent to ventilated attic areas.

The Energy Star Thermal Bypass Inspection Checklist requires that an air barrier be placed on all sides of the insulation. This means that the back sides of knee walls need to be sheathed and sealed. Thin-profile cardboard sheathing with ccSPF works well here. Since ccSPF is air impermeable, the insulation does not have to fill the entire cavity, and it meets the air barrier requirement. Some codes require R-19 insulation, which is difficult to do in a 3 1/2-inch space with batt insulation, but 2 inches of ccSPF provides about R-19.5.

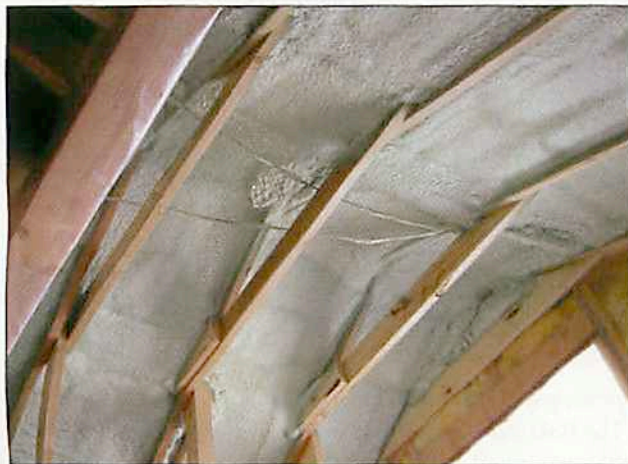
Sloping Roof Areas

The sloping areas in a cathedral ceiling can be the sites for significant thermal bypasses. These areas are not only difficult to insulate but are difficult to ventilate. Yet ccSPF solves both problems. Placing ccSPF directly on the underside of the roof deck also creates a secondary rain barrier, and because of ccSPF's high R-value and low permeability, moisture is not likely to condense on its surface, eliminating the need for cavity ventilation.

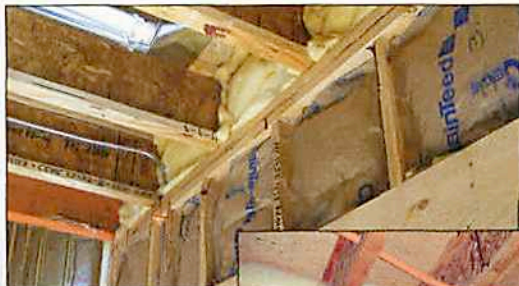
Band-Joint Areas

The band-joint area is typically a major site for air infiltration. These areas are usually very poorly insulated, causing one of the most significant thermal bypass areas. If the home is under a positive pressure (air pushing out from inside) in a heating climate, the air is likely to be at a high humidity level. This can cause frost, and eventually mold, to build up on the back side of the band joist. In a cooling climate that is under negative pressure (air pulled inward — a condition that's commonly caused by leaky HVAC ducts), this can pull hot, humid air from outside, where it is likely to condense and lead to mold problems. The sealing properties of ccSPF will reduce these air-infiltration and energy-loss problems in this troublesome area.

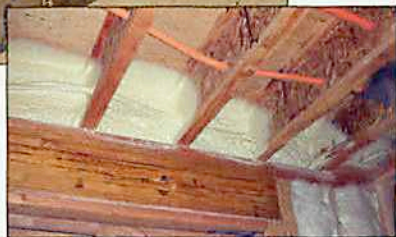
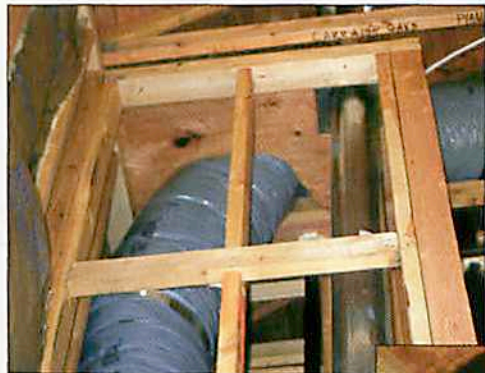
Attic and Crawlspace Bypasses

Attic and crawlspace bypasses are penetrations into the living spaces. Pipes, ducts, flues, and electric wires are the most common reason for these penetrations, and the best way to seal them is often (but not always) with ccSPF. Because ccSPF expands and seals, it does an excellent job of filling voids that allow conditioned air to escape. However, ccSPF should *not* be used to seal around high-temperature areas such as combustion appliance flues.

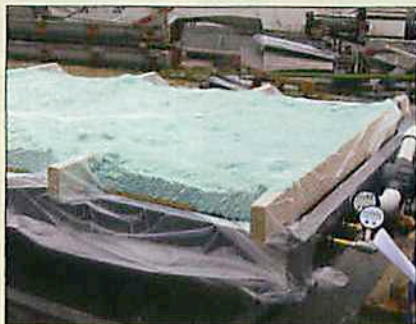
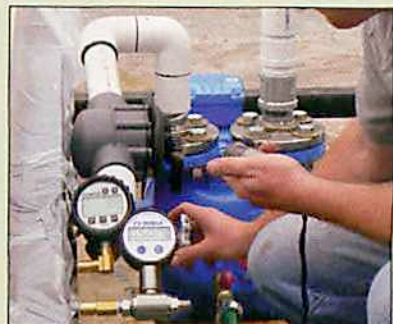
A test panel (above left) in a study at the University of Florida simulates a roof assembly consisting of 1/2-inch OSB fastened to 2x4 framing at 24-inch centers. The framing bays have been filled with closed-cell spray foam. During the study, the assembly was placed on a pressure chamber and a vacuum pump (above right) drew a vacuum that was increased in 15-psf intervals until the assembly failed and the sheathing popped off the framing. For the fully foamed assemblies, this occurred at around 240 psf. The assemblies that had ccSPF fillets installed failed at 160 psf. The assemblies with sheathing alone nailed only with nails (6/12 schedule) failed at about 75 psf.

Recent research conducted at the University of Florida has demonstrated that closed-cell spray foam (ccSPF) applied to the underside of roof decking effectively bonds the sheathing to the framing, significantly increasing uplift resistance. The study, conducted by Dr. David O. Prevatt and funded by Honeywell and Huntsman, two makers of ingredients that go into ccSPF, found that 3 inches of the foam sprayed between framing members provided a threefold increase in uplift resistance as compared with traditionally installed roof sheathing panels. While these results sound impressive, Dr. Prevatt points out that the increase provides the same benefits as increasing the nailing schedule to a 6/6 schedule (every 6 inches along panel edges and every 6 inches in the field) from the usual 6/12 schedule. What was perhaps most impressive is that using only spray foam to glue the sheathing to the framing provided almost as much resistance (178 to 209 psf) to uplift as does 8d common nails (205 psf) installed at the 6/6 schedule. This suggests what may be the biggest structural advantage of a foamed roof assembly — reducing the likelihood of a roof blowoff when the sheathing doesn't get nailed off with enough nails or when too many nails miss their mark.

The uplift study also evaluated the benefit of installing a "fillet": a 3x5-inch bead of ccSPF in the corners between the sheathing and the roof framing. The fillet method effectively doubled the uplift resistance of the baseline assembly of 2x4 framing on 24-inch centers sheathed with 1/2-inch OSB nailed on a 6/12 schedule.
